## **Incident in a brewery due to the installation of a new X-ray tube in a fill-level gauge**

Dejan Zontar, Slovenian Radiation Protection Administration

Peter Shaw, Public Health England

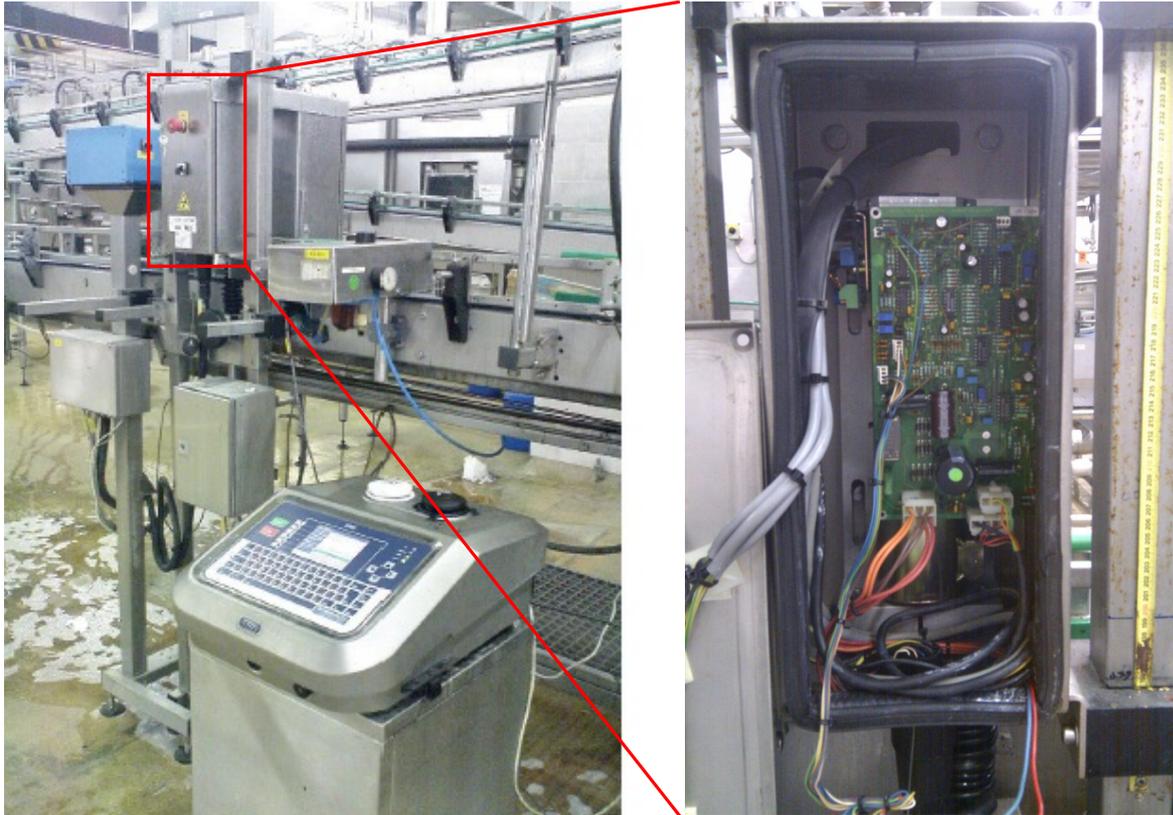
Using a dose rate meter he could measure almost no reading at the detector position, but there was a significant dose rate at the position he was occupying. He switched the unit off immediately and contacted radiation protection experts. Further investigations showed that the tube had been mounted incorrectly (by the suppliers) on the circuit board, such that the tube window was facing a wrong direction (towards the worker instead of towards the line).

**Photographs: the original gauging system on the can filling line (left), and inside the gauge cabinet (right): the X-ray tube is mounted on the rear of the circuit board.**

- A programme of workplace monitoring was introduced after the incident and personal dosimeters for maintenance staff are under consideration.
- Due to an old age and unavailability of spare parts the level gauge in question was replaced by a new one.

- Basic radiation protection training for all workers working in vicinity of sources of ionising radiation was organised after the incident.
- Additional measures were taken by the brewery to prevent such incidents in the future, as it was considered that the company should not rely on suppliers to provide properly constructed and functioning parts.
- One of the problems identified was the difficulty of obtaining data from companies in other countries. In this case the absence of information from the tube supplier prevented a reliable dose reconstruction.
