Management of industrial Radiography incident on NPP

EAN - BERNE 15/03/2016

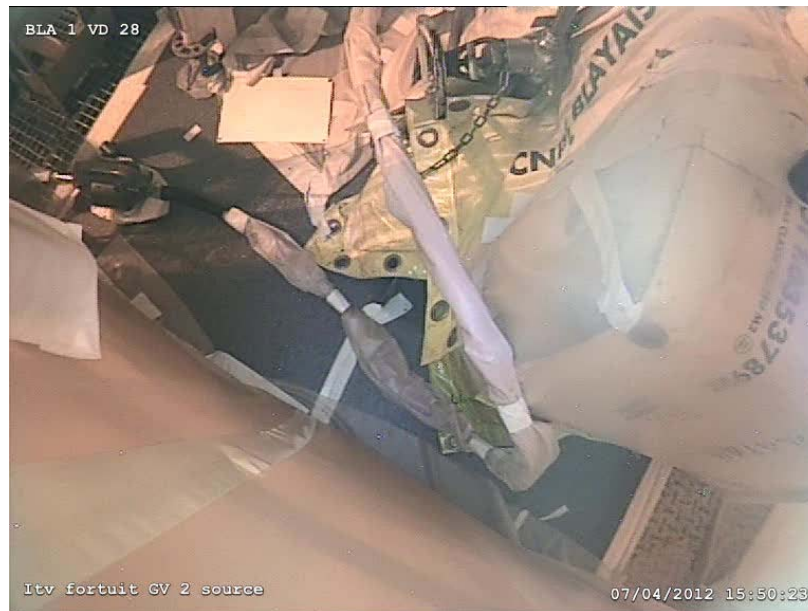
- The area is « dirty »(contaminated) : → it's impossible to see something inside from outside.
- Access is blocked, tight area : → robots can't be use.
- Access by a ladder near the source : → dose rate very high, humans can't be sent.

Above situation

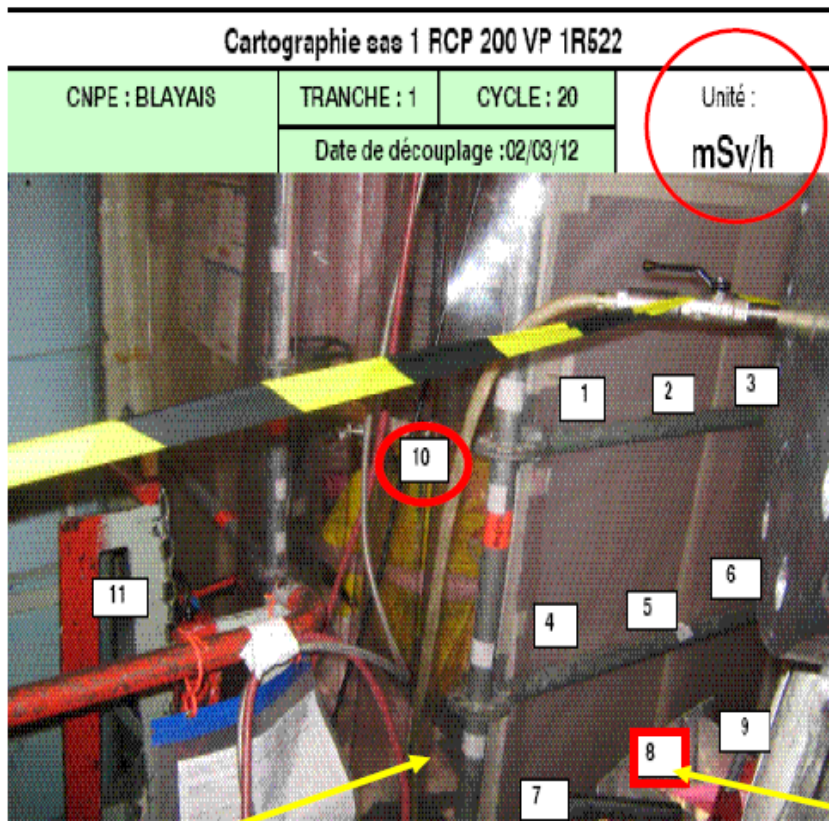
POINTS	DDD Contact	DDD Ambient
1	150	
2	110	
3	144	
4	179	
5	263	
6	316	
7	423	
8	2000	
9	750	
10		300
11		50

Device's position

Source position?

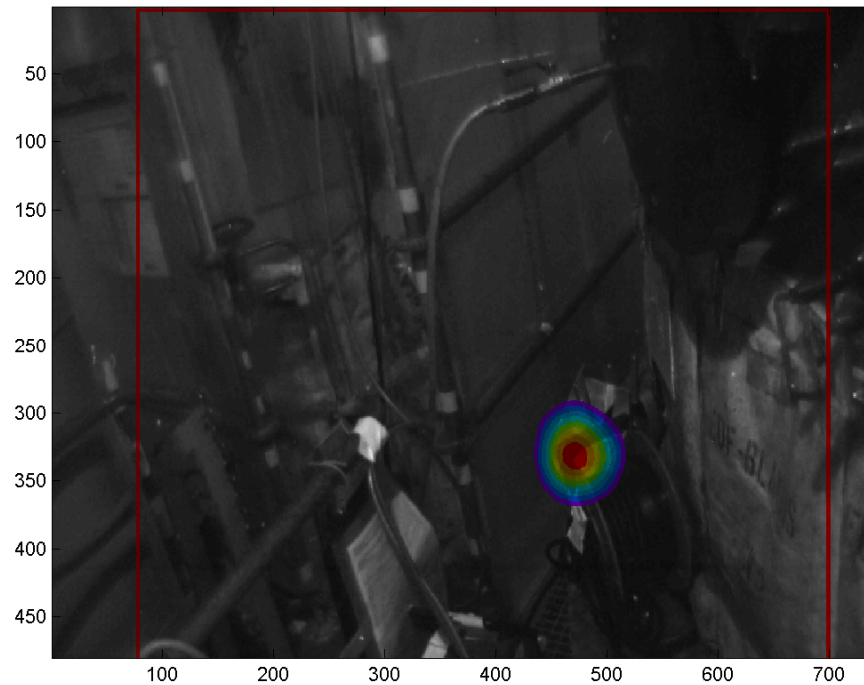
The source is settle in the guide tube about 700 mm of the connexion between device and guide tube

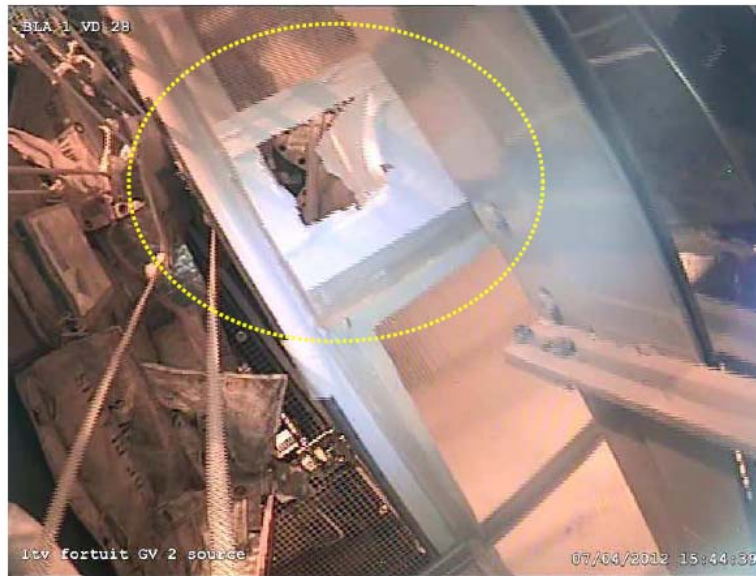
- ▶ First Step : Decrease the dose rate (dose rate > 300 mSv/h at 1 m) :
 - Without exposing workers,
 - Taking account of the environnement.

By cutting the roof, and using small lead bags

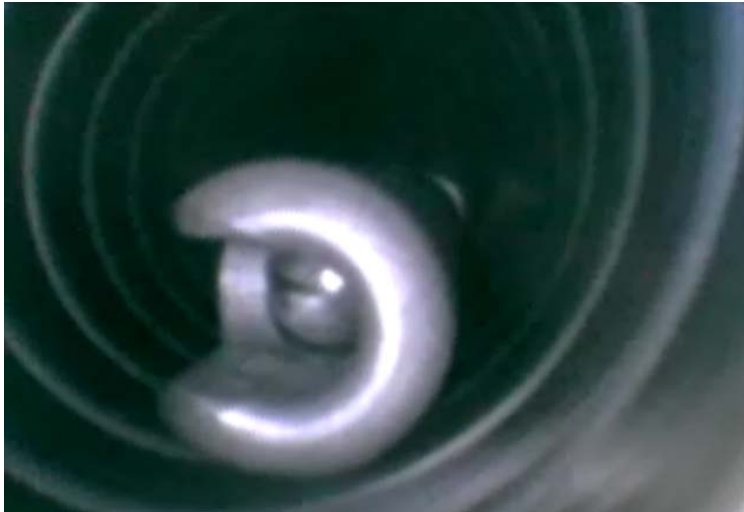
Finally, source holder was disconnected...but we don't know why!
(Material Failure?, Human error?)
