Industrial radiography incident in France IRSN Feurs (42) site

16th European ALARA Network Workshop
Berne, Switzerland
14 - 16 March 2016

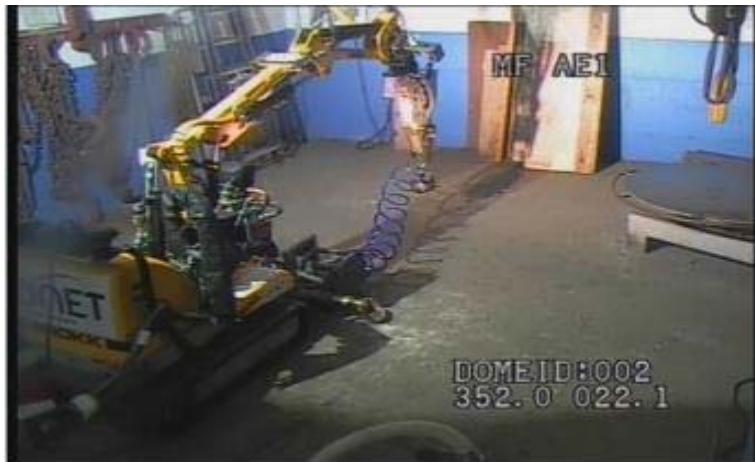
Brokk with measuring probe

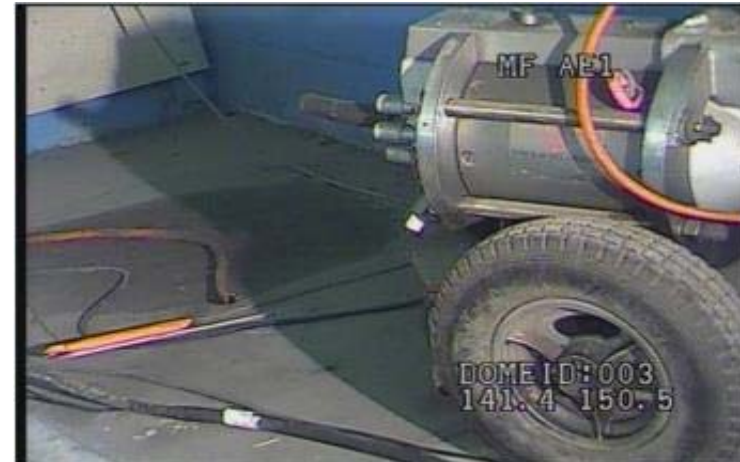
GR 50 with its cut ejection tube
