Management of industrial Radiography incident on NPP

EAN - BERNE 15/03/2016

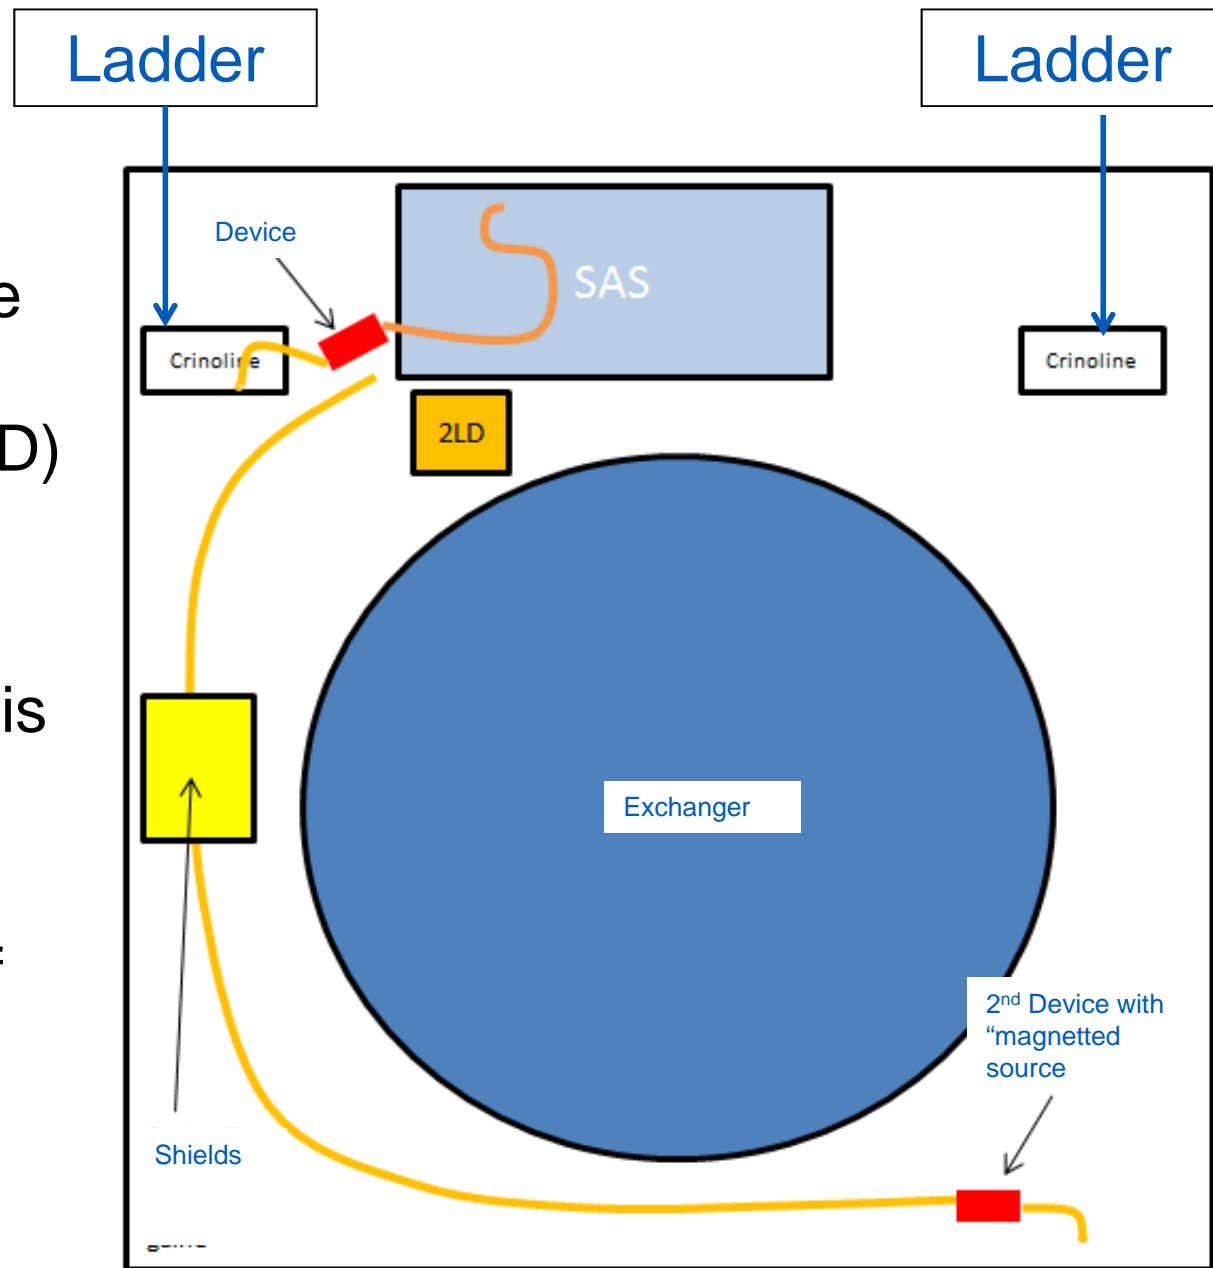
- ▶ The goal : get the source in a shielded box (2LD)
- ▶ Dose associated with the incident is 13 man.mSv
- ▶ Cost : 25 days of inactivity in this area = 25 M€.

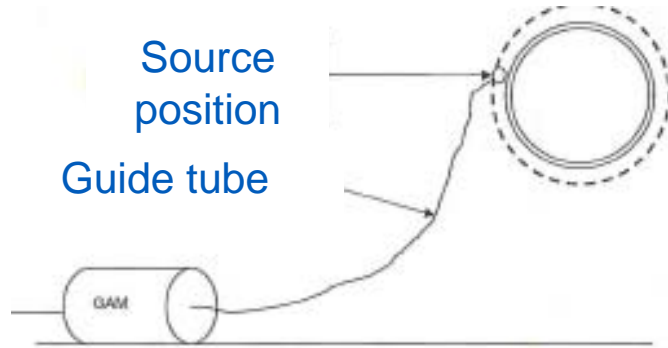
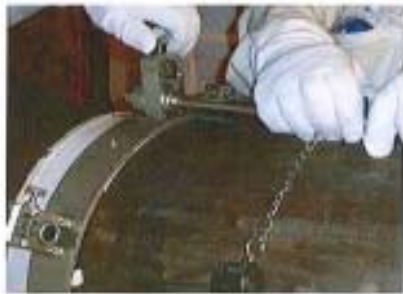
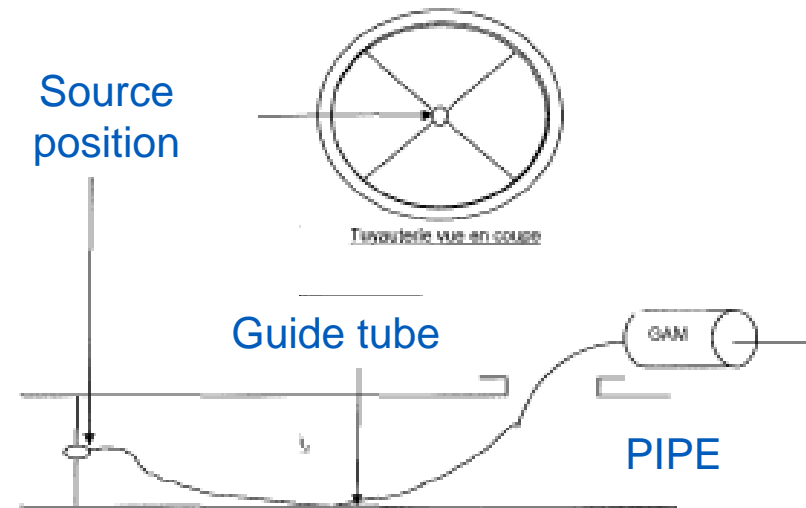
- ▶ Doing an exposure needs to hold the collimator or the guide tube but sometimes it could be complicated to act in case of incidents

We are developing new equipments to treat the incident in a better way and to release the collimator or the guide tube when its fixed on pipe or anything else.
